# Manhole Inspection Summary

Manhole # S71E1\_006MH

Insp Date: **2/13/08 12:26 PM**

**Location** Address: **6589 St Helena Ave.**

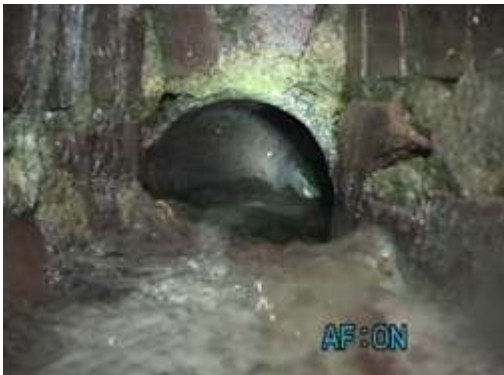
Defect 1

Broken pipe seal 11:00 outgoing 12 O'Clock

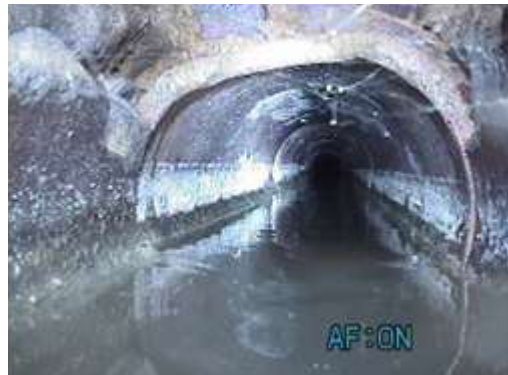
Defect 2

cracked pipe seal 1:00 incoming 6 O'Clock

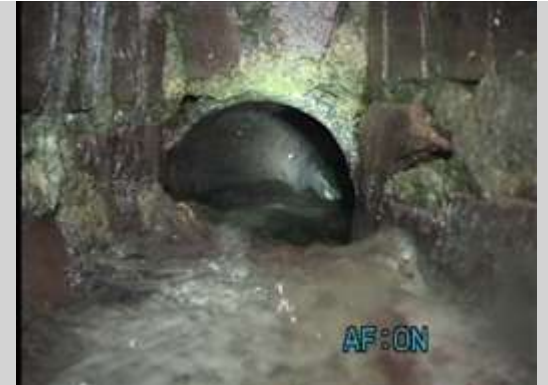
12 O'Clock Outflow

8 in. Circular Gravity Sewer  
Pipe Out @ 12 O'Clock

Pipe Height: **8.4** (in.) Rod and Bar (Angled)  
Pipe Material: **Clay** ☐ Pipe Lined  
Invert Depth: **6.13** (ft.) Flow Characteristics: **Fast**  
Deposits: ☐ None ☐ Mud ☒ Sludge ☒ Debris ☐ Grease  
Silt Depth: **0.5** (in.) Deposits Extent: **Medium**  
Infiltration: **Evidence** Pipe Seal Cond: **Broken**

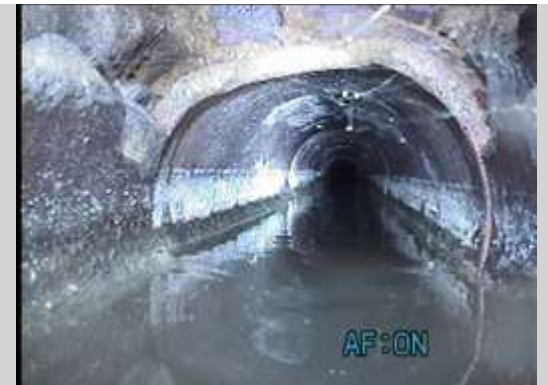
4 O'Clock Inflow

8 in. Circular Gravity Sewer  
Pipe In @ 4 O'Clock

Pipe Height: **8.4** (in.) Rod and Bar (Angled)  
Pipe Material: **Clay** ☐ Pipe Lined  
Invert Depth: **5.83** (ft.) Flow Characteristics: **Fast**  
Deposits: ☐ None ☒ Mud ☒ Sludge ☐ Debris ☐ Grease  
Silt Depth: **0.5** (in.) Deposits Extent: **Medium**  
Infiltration: **None** Pipe Seal Cond: **Cracked**

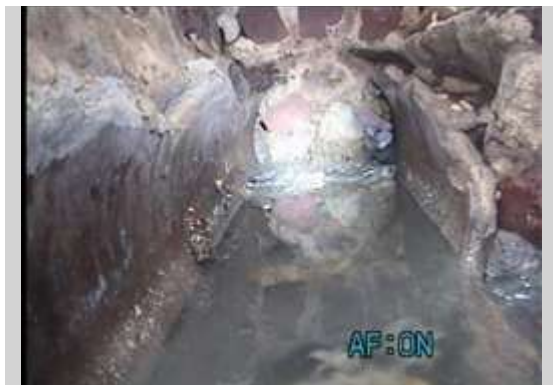
9 O'Clock Inflow

Comments **I9 CONNECTION TO COUNTY SS IS ABANDONED AND BLOCKED.**

Abandoned. Plugged with concrete and brick.
